# **Flood Mitigation Needs Assessment**

**Six Mile Creek  
Tompkins County, New York**

**October 2003**

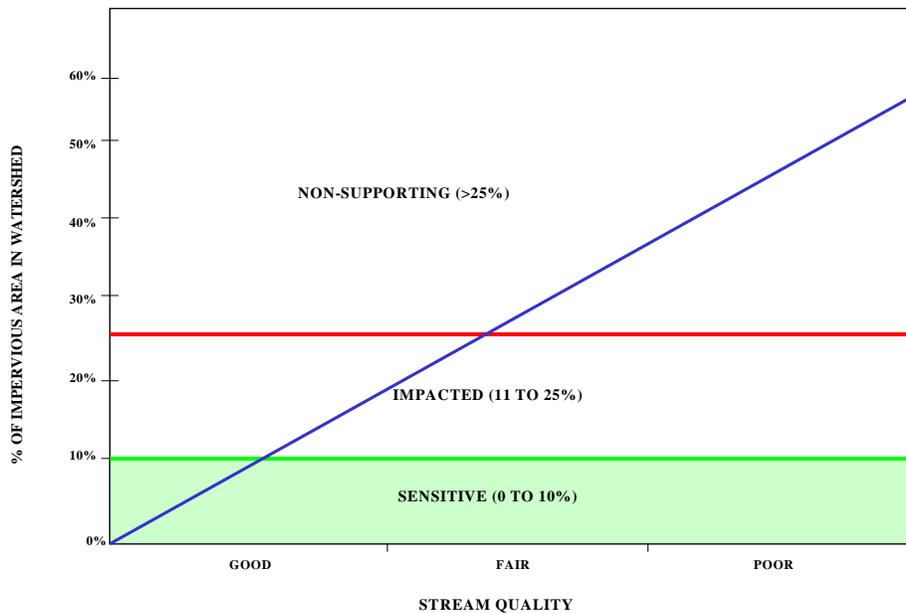
**Figure 4-1  
Relationship of Imperviousness to Water Quality**

*Source: Schueler & Claytor, 1996 ASCE*

Detailed studies of numerous watersheds have shown that the physical, biological, and chemical (water conditions) usually deteriorate as the watershed becomes developed. The percentage of the watershed covered with impervious material such as rooftops, parking lots, roadways, and driveways is often used as an indication of urbanization. Research has demonstrated the following relationships between watersheds impervious cover and the streams condition. (Center for Watershed Protection, 1998) This information provides an initial method to rapidly assess watersheds susceptible to change.

Streams with 10 to 25 percent impervious cover usually are impacted with erosion channel deterioration, unstable banks, reduced habitat, reduced biodiversity, and declining water quality. Streams within watersheds of over 25 percent impervious cover tend to be flood prone, highly unstable, with poor water quality and limited aquatic life. Figure 4-1 illustrates the relationship between impervious cover and stream quality, information that can be used to categorize streams as sensitive, impacted, or non-supporting.
